# Watershed at a Glance

Water Quality  
**2023**

# Pipe Creek Report Card

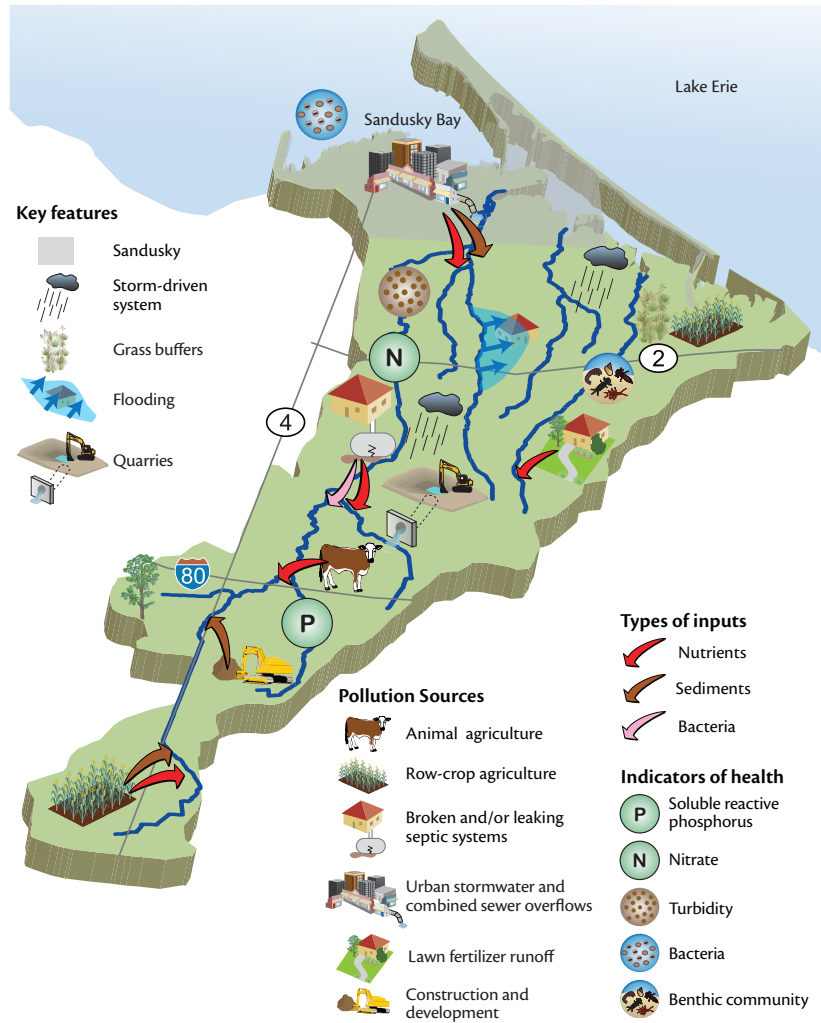
Pipe Creek is a 48.5 square mile watershed which includes three main streams: Pipe Creek, Hemminger Ditch, and Plumbrook. The watershed is a mix of 3 landuses: Urban (41%), Agriculture (39%), and Natural (20%), that flows from Bellevue to Sandusky.

Two lake sites located on the shoreline (see map) of Pipe Creek are monitored by the Erie County Health Department. In 2023, Battery Park and the Pipe Creek Wildlife Area both scored 100% and 92.7% respectively, meaning nearly all samples indicated low risk of illness from contact with water.

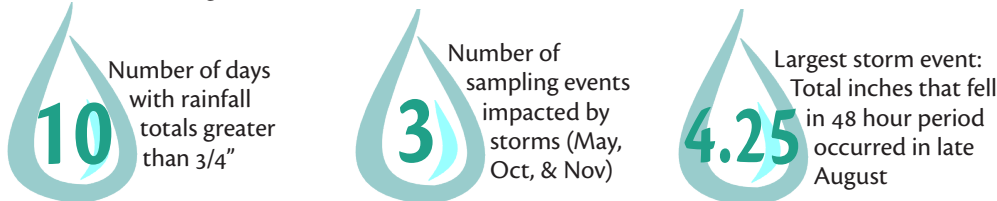
# Weather During our Sampling Period

Observations collected from three CoCoRAHS.org stations revealed a dry spring and a wet summer. Most months fell well below average for rainfall, while July and August were the only months above average.

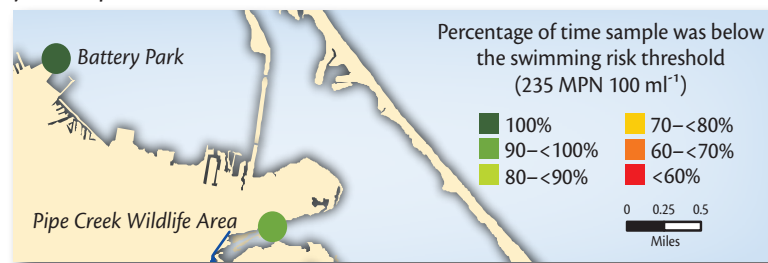
## 2023 Beach Health and Safety

Note that the bacteria scoring scale is more stringent than water quality indicators because of the high variability and importance to human health and safety.
