Watershed at a Glance

Mills Creek Report Card

Mills Creek 2025 Report Card

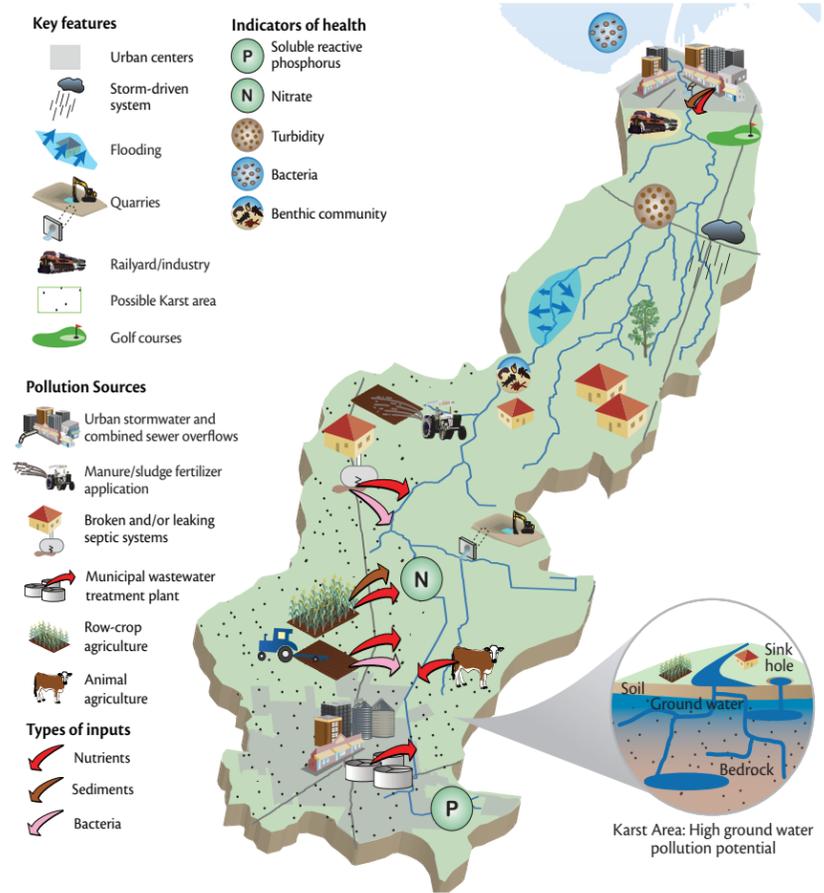
Mills Creek is a 42.4 square mile watershed with unique karst geology: sinkholes, springs, and fractured bedrock connecting the surface and groundwater at several locations. The watershed is a mix of 3 landuses: Agriculture (67%), Urban (26%) and Natural (7%), that flows from Bellevue to Sandusky.

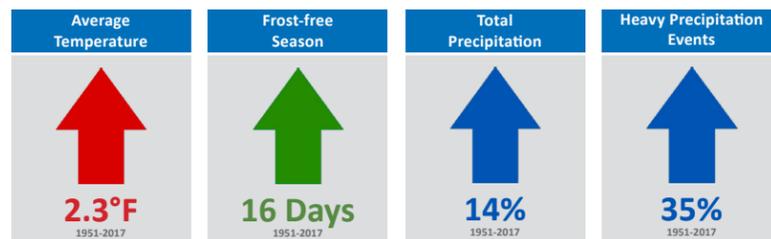
Climate Trends in the Great Lakes

These trends are an analysis of weather observations provided by the National Oceanic and Atmospheric Administration's (NOAA) Regional Integrated Sciences and Assessment Team. While warmer temps & increased growing days benefit food production, increases in precipitation and intensity could drive more polluted run off resulting in more algal blooms.

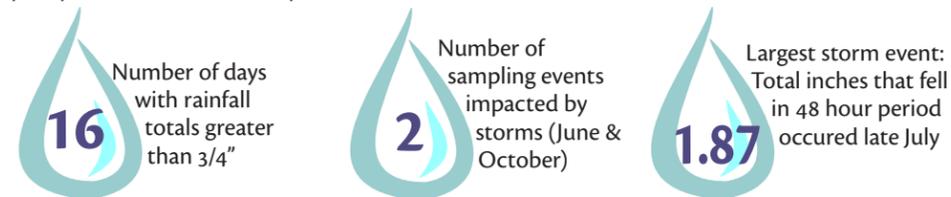
Weather During our Sampling Period

Rainfall from April through July was at or above the 30-year average, with nearly 6 inches recorded in July. Although most fall months were below normal, the higher spring and summer precipitation led to two sampled storm events.

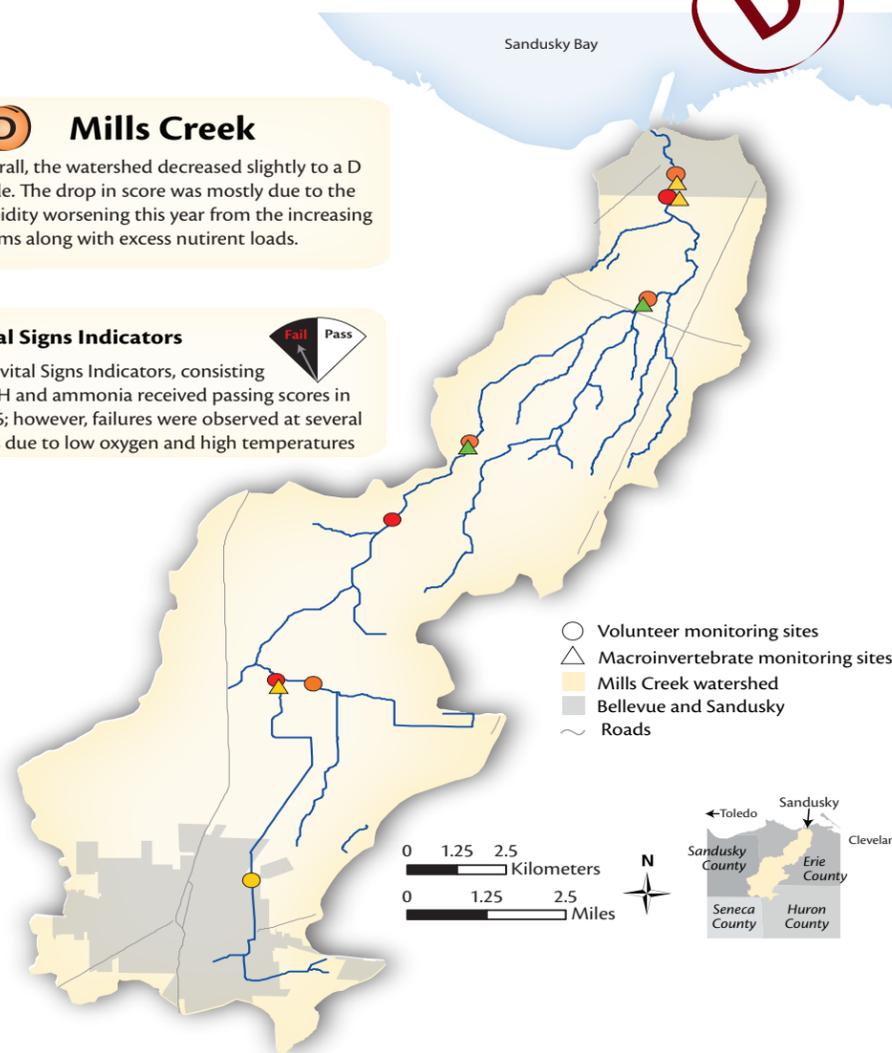
Overall, the watershed decreased slightly to a D grade. The drop in score was mostly due to the turbidity worsening this year from the increasing storms along with excess nutrient loads.

The vital Signs Indicators, consisting of pH and ammonia received passing scores in 2025; however, failures were observed at several sites due to low oxygen and high temperatures
