Watershed at a Glance

Old Woman Creek Report Card

Old Woman Creek 2025 Report Card

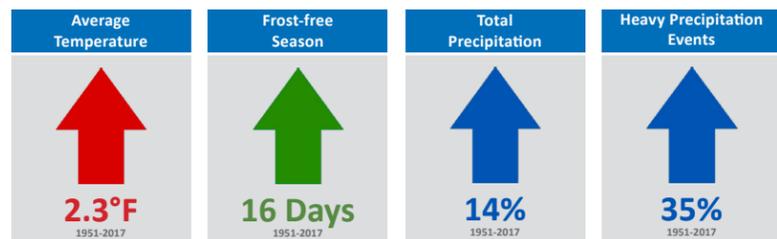
Climate Trends in the Great Lakes

These trends are an analysis of weather observations provided by the National Oceanic and Atmospheric Administration's (NOAA) Regional Integrated Sciences and Assessment Team. While warmer temps & increased growing days benefit food production, increases in precipitation and intensity could drive more polluted run off resulting in more algal blooms.

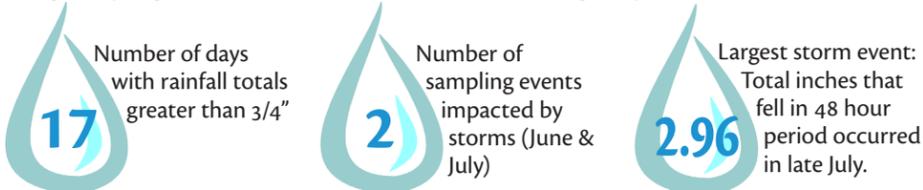
Weather During our Sampling Period

Rainfall totals for April through July were well above normal, with July receiving twice the 30-year average (3.9 inches), while most fall months were below. The increased precipitation during the spring and summer led to two storm events being sampled.

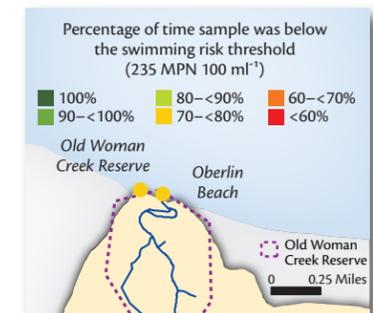
Two lake sites located on the public/private barrier beach (see map) of Old Woman Creek (OWC) are monitored by the Erie County Health Department. In 2025, OWC Reserve Beach scored a 74% and Oberlin Beach scored a 79%, meaning that nearly all samples indicated low risk of illness from contact with water. Note that the bacteria scoring scale is more stringent than water quality indicators because of the high variability and importance to human health and safety.

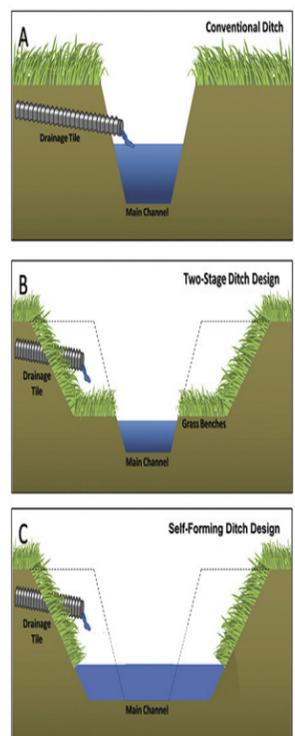
Conservation ditches improve water quality by reshaping traditional drainage ditches (A). Using designs such as two-stage channels with internal benches (B) or widened natural channels (C), these projects increase water capacity while helping trap sediment and nutrients. Since 2010, three conservation ditch projects totaling more than 3,400 feet have been installed in the Old Woman Creek watershed.

A decade later, researchers from The Ohio State University evaluated one of the headwater projects and found it performed better than similar ditches across Ohio. Sediment samples collected from the ditch also revealed high levels of nutrients and organic matter that may have agricultural value.

In response, the Erie Conservation District and Old Woman Creek Reserve partnered with The Ohio State University to better understand how these ditches function over time and whether the captured soil and nutrients can benefit nearby row crop farms. Because some of the earliest ditch sections needed cleaning, the maintenance work provided an opportunity to study the system's long-term performance.

Beginning in 2024, researchers started monitoring stormwater quality upstream and downstream of the project. Soil samples were also collected from dredged material and from farm fields before and after the material was applied to the land. Monitoring will continue over the next several growing seasons to evaluate water quality improvements and crop response!
