Water Quality

2025

Pipe Creek Report Card

Pipe Creek 2025 Report Card

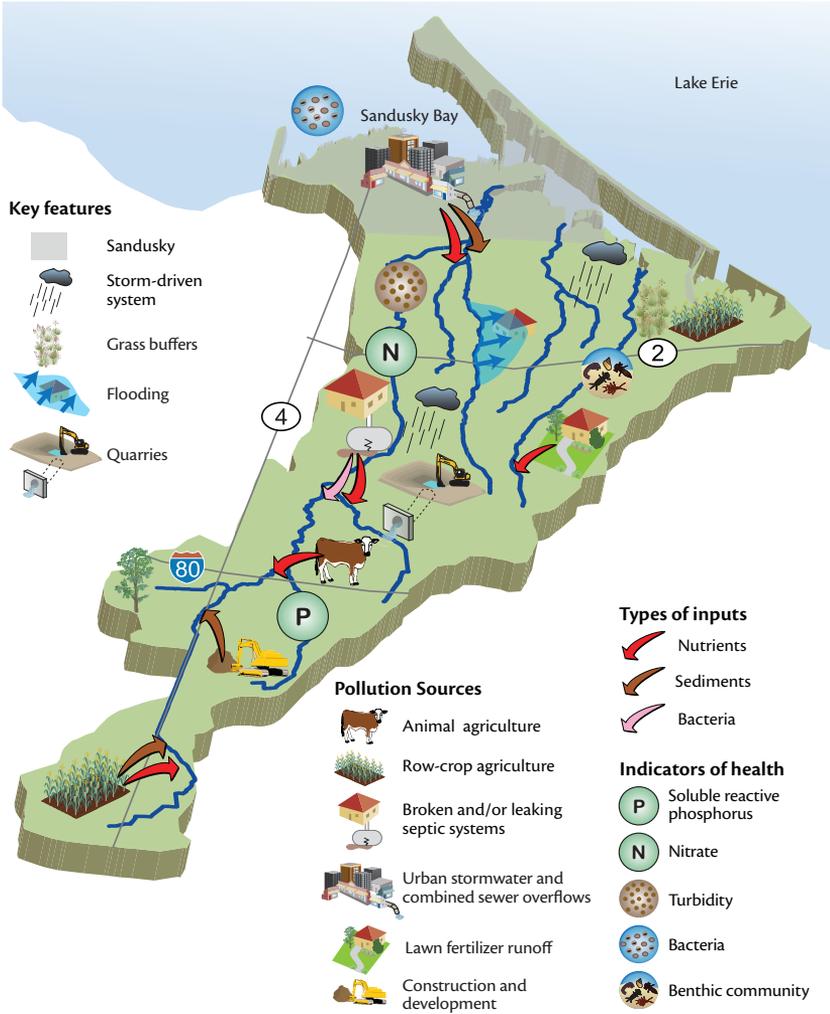
Pipe Creek is a 48.5 square mile watershed which includes three main streams: Pipe Creek, Hemminger Ditch, and Plumbrook. The watershed is a mix of 3 landuses: Urban (41%), Agriculture (39%), and Natural (20%), that flows from Bellevue to Sandusky.

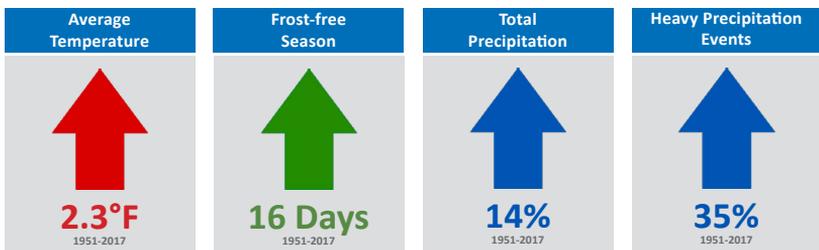
Climate Trends in the Great Lakes

These trends are an analysis of weather observations provided by the National Oceanic and Atmospheric Administration's (NOAA) Regional Integrated Sciences and Assessment Team. While warmer temps & increased growing days benefit food production, increases in precipitation and intensity could drive more polluted run off resulting in more algal blooms.

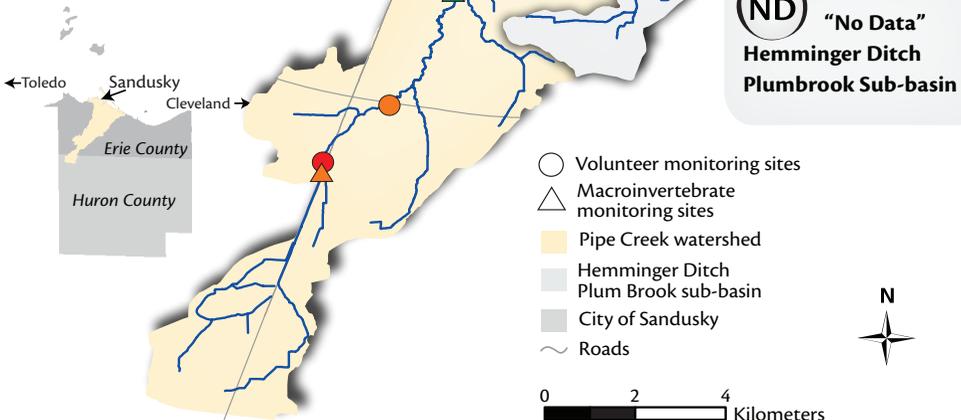
(ND) "No Data"
Hemminger Ditch
Plumbrook Sub-basin

- Volunteer monitoring sites
- △ Macroinvertebrate monitoring sites
- Pipe Creek watershed
- Hemminger Ditch Plum Brook sub-basin
- City of Sandusky
- ~ Roads

****SITE CHANGE:** Perkins Ave site was moved upstream to Milan Rd due to bridge construction.

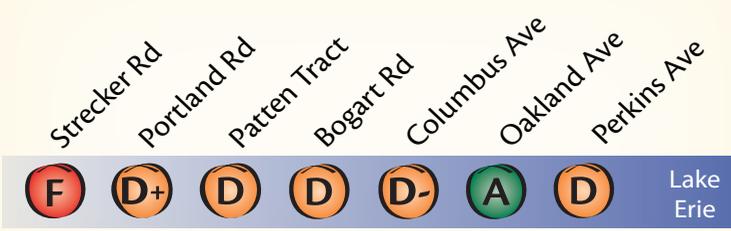
Creek Site Water Quality Scores

Sites are listed from headwaters (south) to mouth (north).

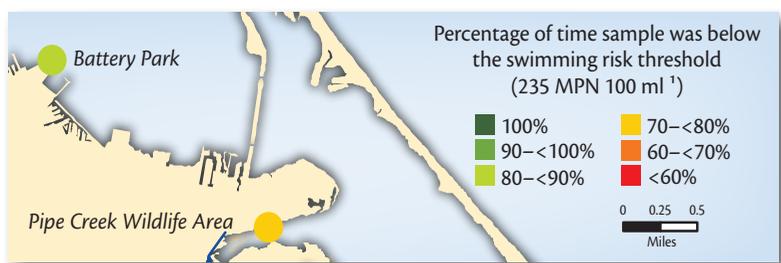
2025 Beach Health and Safety

Two Pipe Creek shoreline sites are monitored for bacteria by the Erie County Health Department. During the 2025 swimming season, Battery Park had advisories on 15 of 76 sampled days (20%), while Pipe Creek Wildlife Area had advisories on 39 of 100 days (39%), indicating a risk of illness from water contact on about one-fifth and two-fifths of the season, respectively.

Note that the bacteria scoring scale is more stringent than water quality indicators because of the high variability and importance to human health and safety.
